Marshall Mega Site, Calhoun County, MI

Vibration Monitoring and Analysis

FINAL REPORT

March 4, 2022

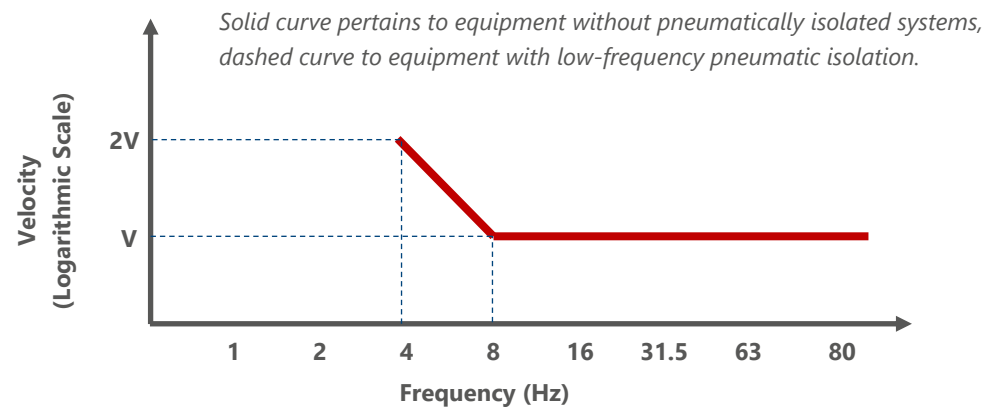
1. Value of V in figure below.

A set of commonly referenced vibration criteria are shown in Table 6, which provide a guide for designers of vibration-sensitive manufacturing facilities and equipment. The vibration criteria are velocity spectra in 1/3-octave bands, and therefore can be compared to the observed 1/3-octave RMS vibration amplitudes in Table 5.

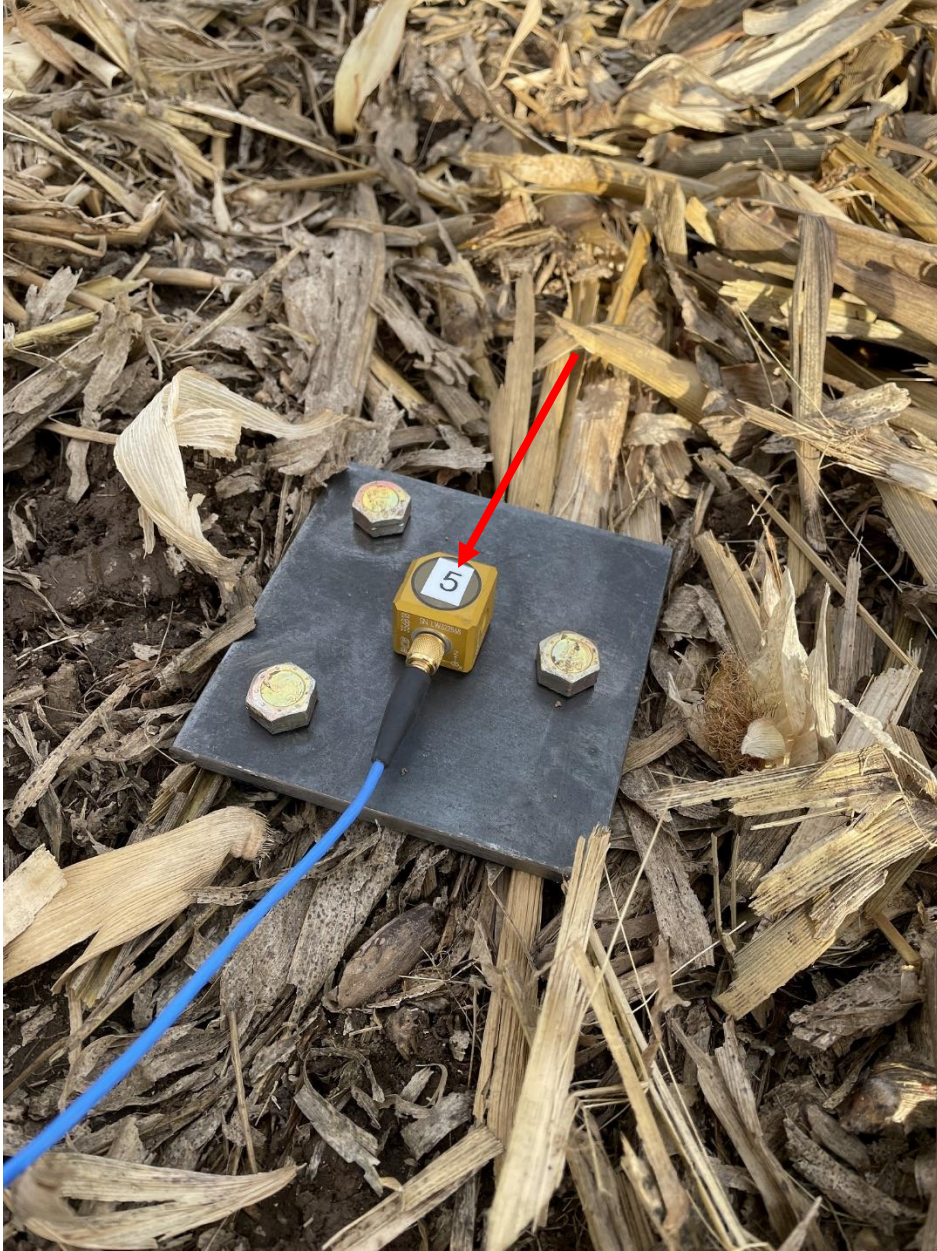
Figure 5. Typical accelerometer installation without cover. Sensor indicated by red arrow.

Each accelerometer was mounted to a steel plate, which was secured in place by three ground anchors as shown in Figure 5. Each accelerometer assembly was covered by a weather-resistant housing (Figure 6) with colored marking flags installed nearby (Figure 7). One of the four accelerometers in each vibration monitoring system was typically located within a few feet of the DAQ (labeled as Sensor 4 in Figure 3), and the other three accelerometers (labeled as Sensors 1, 2, and 3 in Figure 3) were located at various distances away from the DAQ.

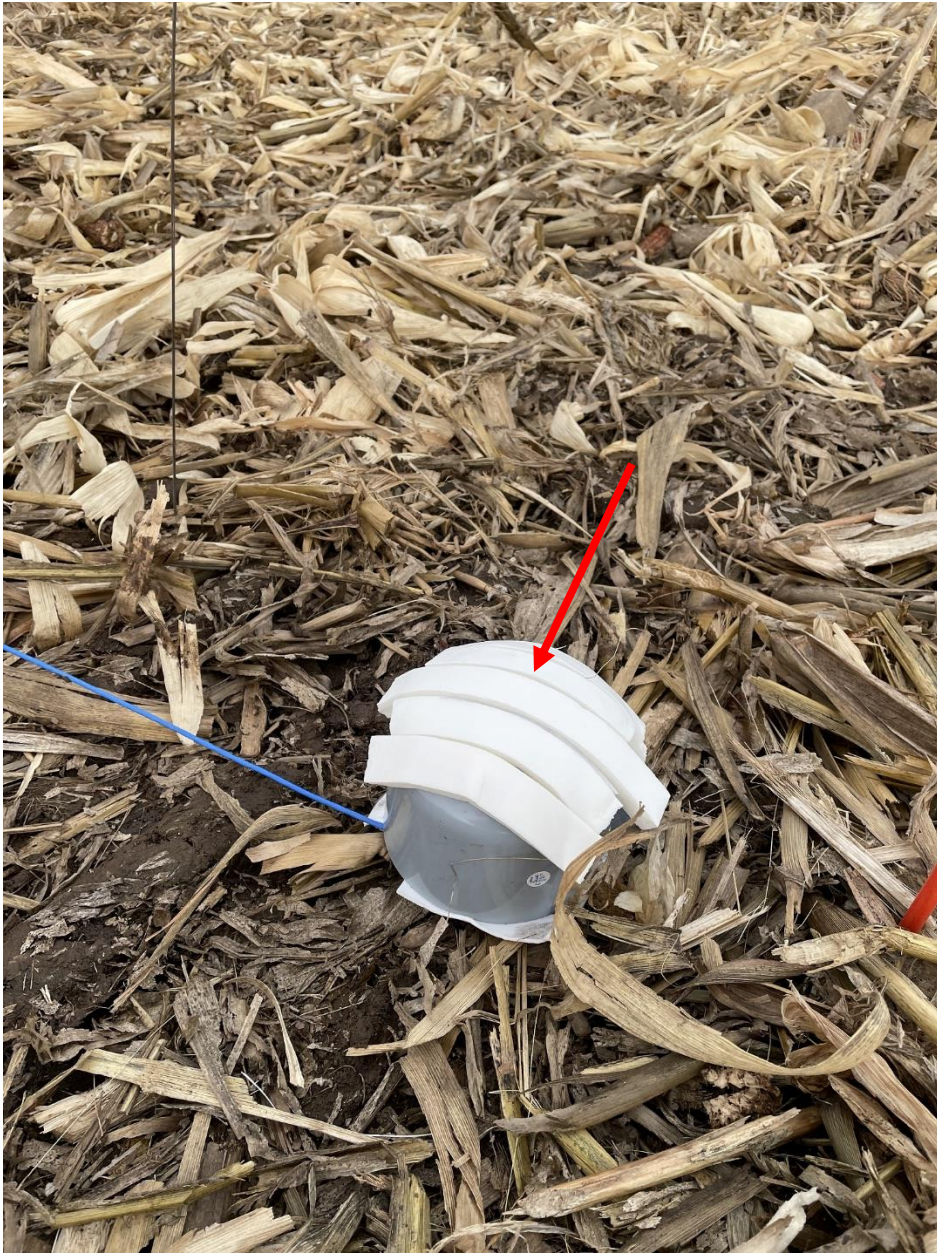
Figure 6. Typical accelerometer installation with cover (red arrow).

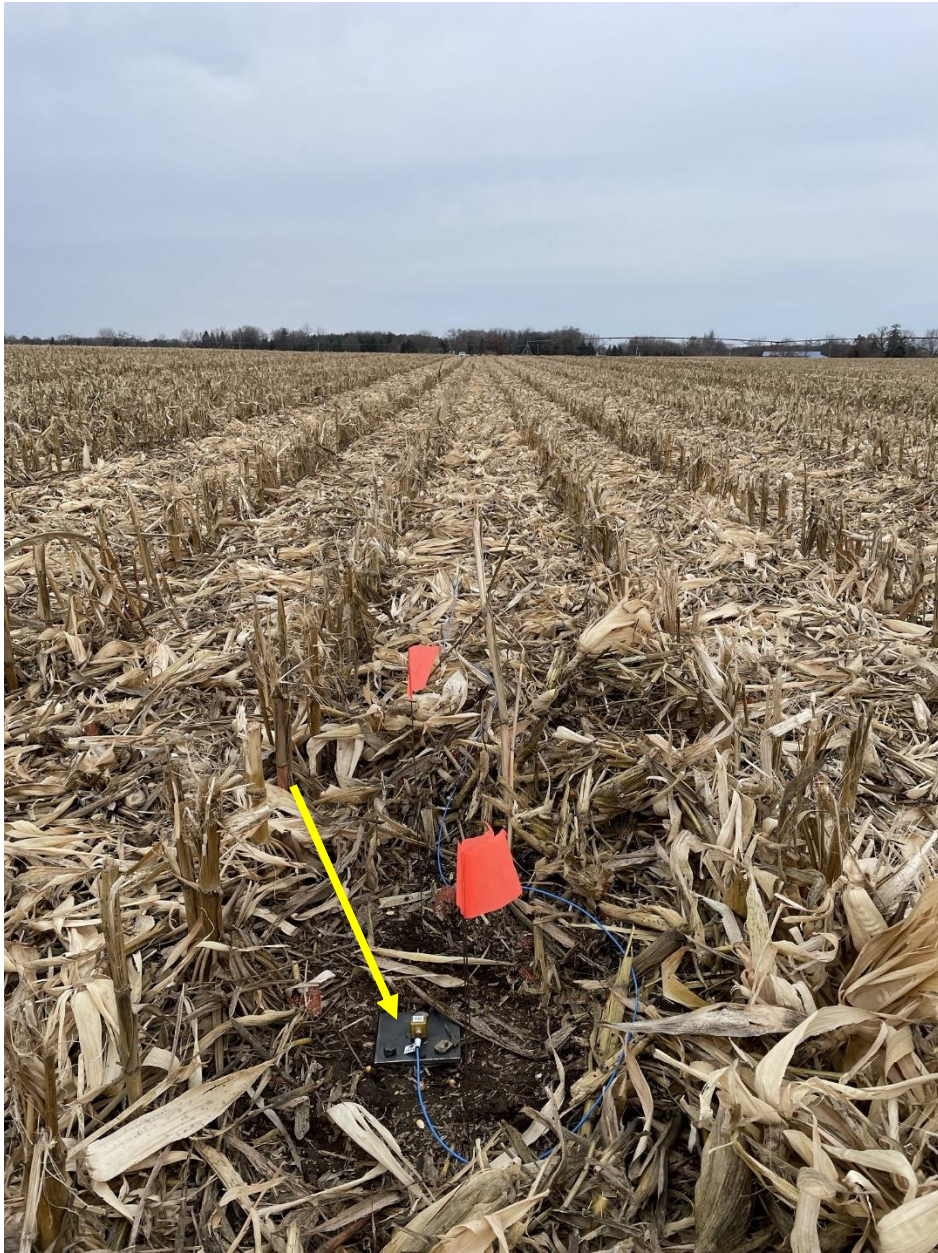
Figure 7. Typical accelerometer (yellow arrow) installation with marker flags.

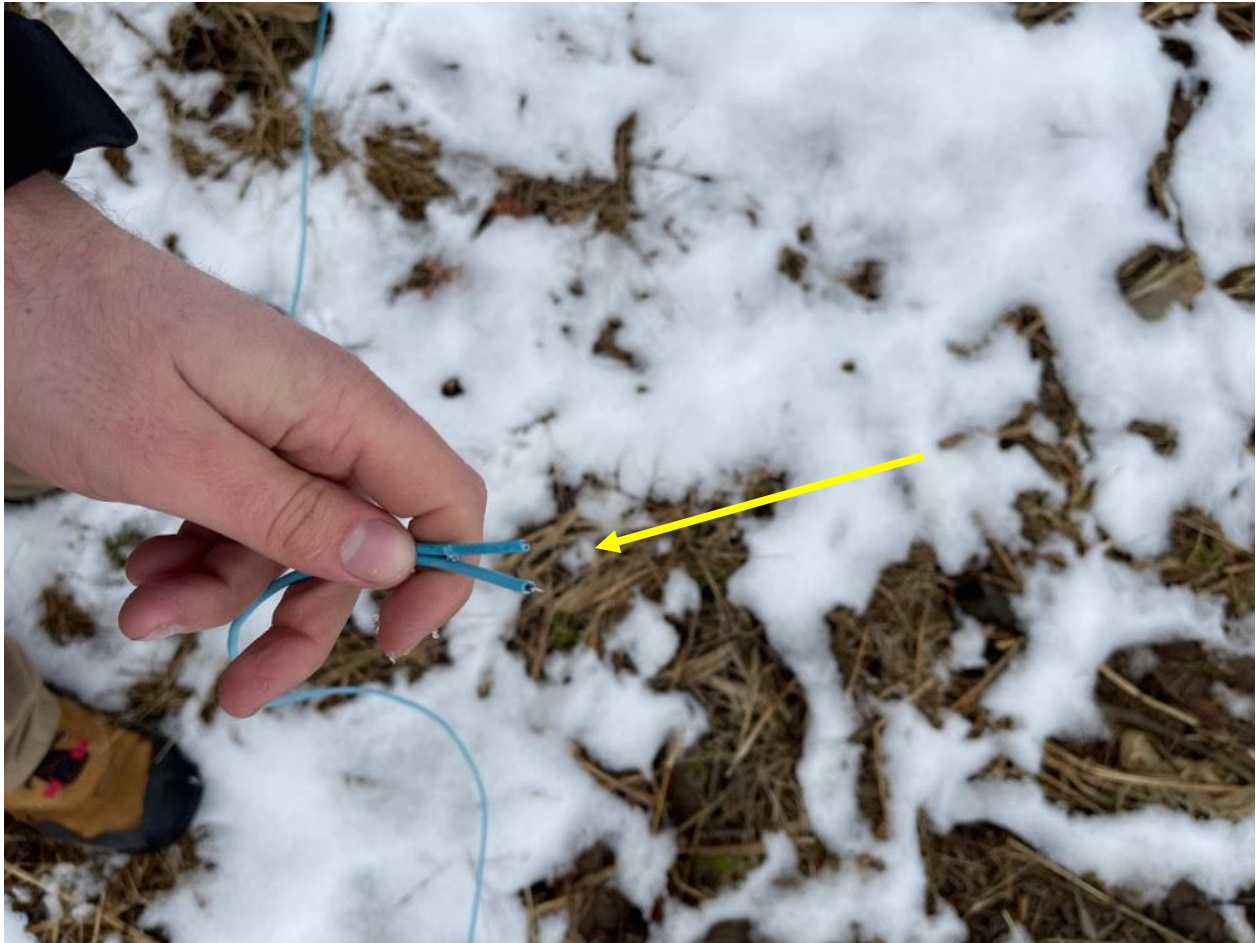
Figure 8. Cabling damaged on site (yellow arrow).

several locations, cabling connecting accelerometers to the DAQ was found to have been damaged (Figure 8), likely by wildlife on the site. This had the effect of adding significant noise to the vibration data. We also observed continuous noise in other sensor channels for which the cabling was not damaged, which likely was the result of electromagnetic interference (EMI) at the site or moisture infiltration at the cable connections. The EMI-related noise was characterized as a steady-state noise at 60 cycles per second (60 Hz). The noise typically masked any underlying vibration data from train activity. In addition, because the noise amplitudes typically exceeded the trigger threshold to record a 1-second waveform as described above, numerous waveforms were stored which provided no useful information. On many days, the noise-related waveforms caused the local storage to be filled, preventing the storage of other waveforms potentially related to train activity.
